# **TITLE Aviation Turbine Engine Diagnostic System (ATEDS) for the OH-58D Helicopter**

**AUTHOR** Larry R. DeMott

**COMPANY NAME** Rolls-Royce Allison  
**COMPANY ADDRESS** P.O. Box 420  
Indianapolis, IN 46206

**Development and SGML-Tagging  
of  
Troubleshooting and Diagnostic  
Procedures  
for  
Rolls-Royce Allison  
T703-AD-700 and 250-C30R/3 Engines,  
and 250-C30R/3 FADEC**

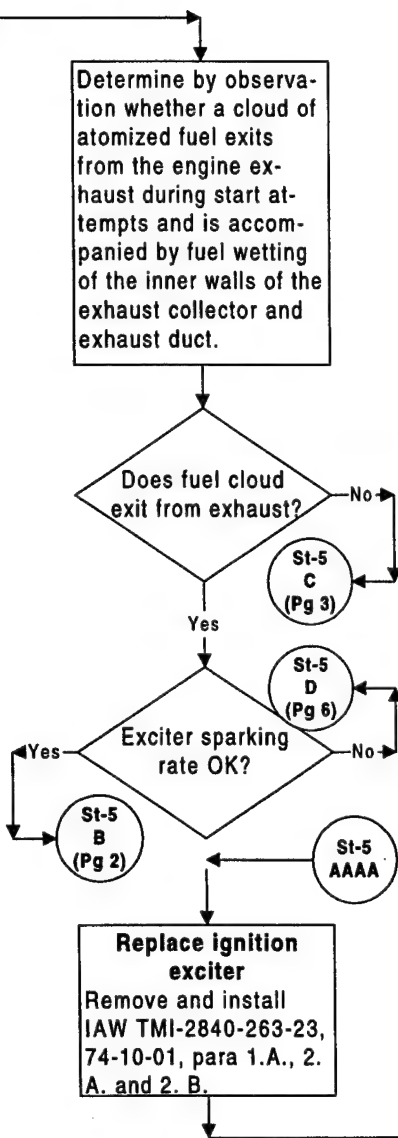
# **St-5 Motors To Required Speed But Does Not Light Off**

During the normal start sequence, fuel flow is automatically initiated at 12% Ng (10% Ng at engine inlet temperatures below 20°F [-6°C]). Failure to light off at (or above) these speeds may be caused by the following:

- ECU fault
- HMU fault
- Fuel supply blocked or restricted, or no boost
- Throttle linkage misrigged
- Faulty ignition exciter, lead, or spark igniter
- Fuel nozzle spray pattern non-uniform
- Fuel nozzle immersion depth improperly set
- Combustion system anomaly
- Water in fuel

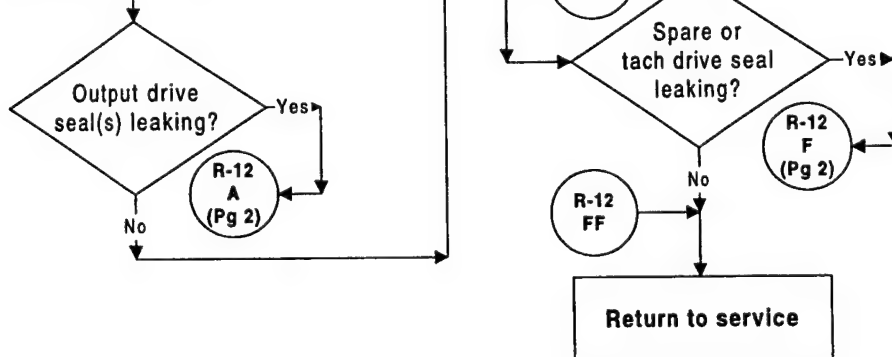
If leakage from any of these seals is high enough to influence engine oil consumption rate or to oil down the engine compartment, the offending seal(s) may be replaced without removing the engine from the aircraft (except for the accessory gearbox breather gear seal).

Np -- Output drive -- front  
 Np -- Output drive -- rear  
 Ng -- Starter-generator drive  
 Ng -- Tachometer drive  
 Np -- Tachometer drive  
 Ng -- Spare drive -- front  
 Np -- Spare drive -- rear  
 Ng -- HMU drive  
 Np -- PMA drive  
 Ng -- AGB breather gear

If a leaking seal requires replacement, proceed as follows:

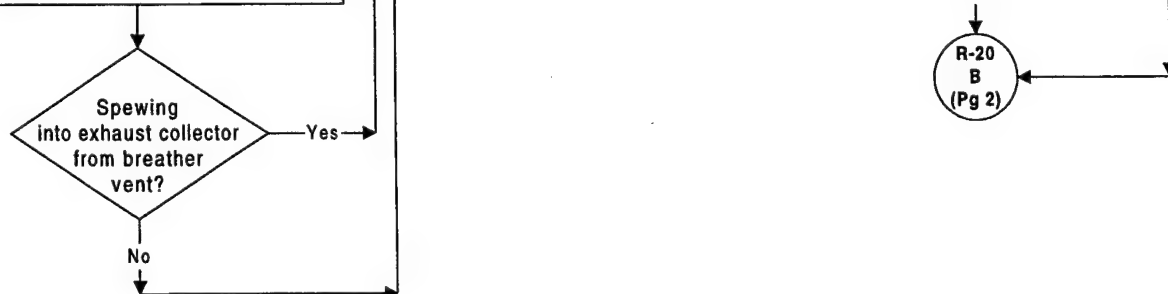
Spewing into the exhaust stream can result from leakage of the lip seal on the centrifugal breather gearshaft, which bypasses the gear and does not benefit from the separating action. Another source is excessive air leakage into the gearbox, from too high compressor seal vent pressure or from worn or damaged turbine seals in cooling air or pressure balance circuits.

If oil spewing or seeping from the accessory gearbox breather vent or tubing joints is encountered, proceed as follows:

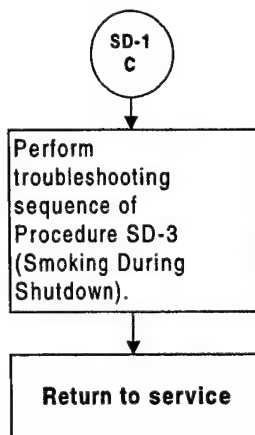
**SD-1. Afterfire (Rising MGT After Shutdown)**

Shutdown afterfires, which are indicated by rising MGT after cessation of Ng rotation, are usually the result of fuel leaking past the HMU cut-off valve, or of internal oil leakage in the turbine section of the engine.

- After the fire is extinguished and MGT has cooled below 150°C (302°F) -- **[do not motor engine to cool]** -- disconnect the fuel nozzle hose at the fuel nozzle end.
- Move the twist grip to cut-off position and observe whether the HMU throttle lever is hard against the minimum (0°) stop. **If not against the stop, do not adjust or rerig at this time.**
- Open the aircraft fuel shut-off valve.
- Direct the end of the fuel nozzle hose into a container, and motor the engine with the starter.
- With the twist grip in the cut-off position, observe whether fuel flows from the fuel nozzle hose during motoring.

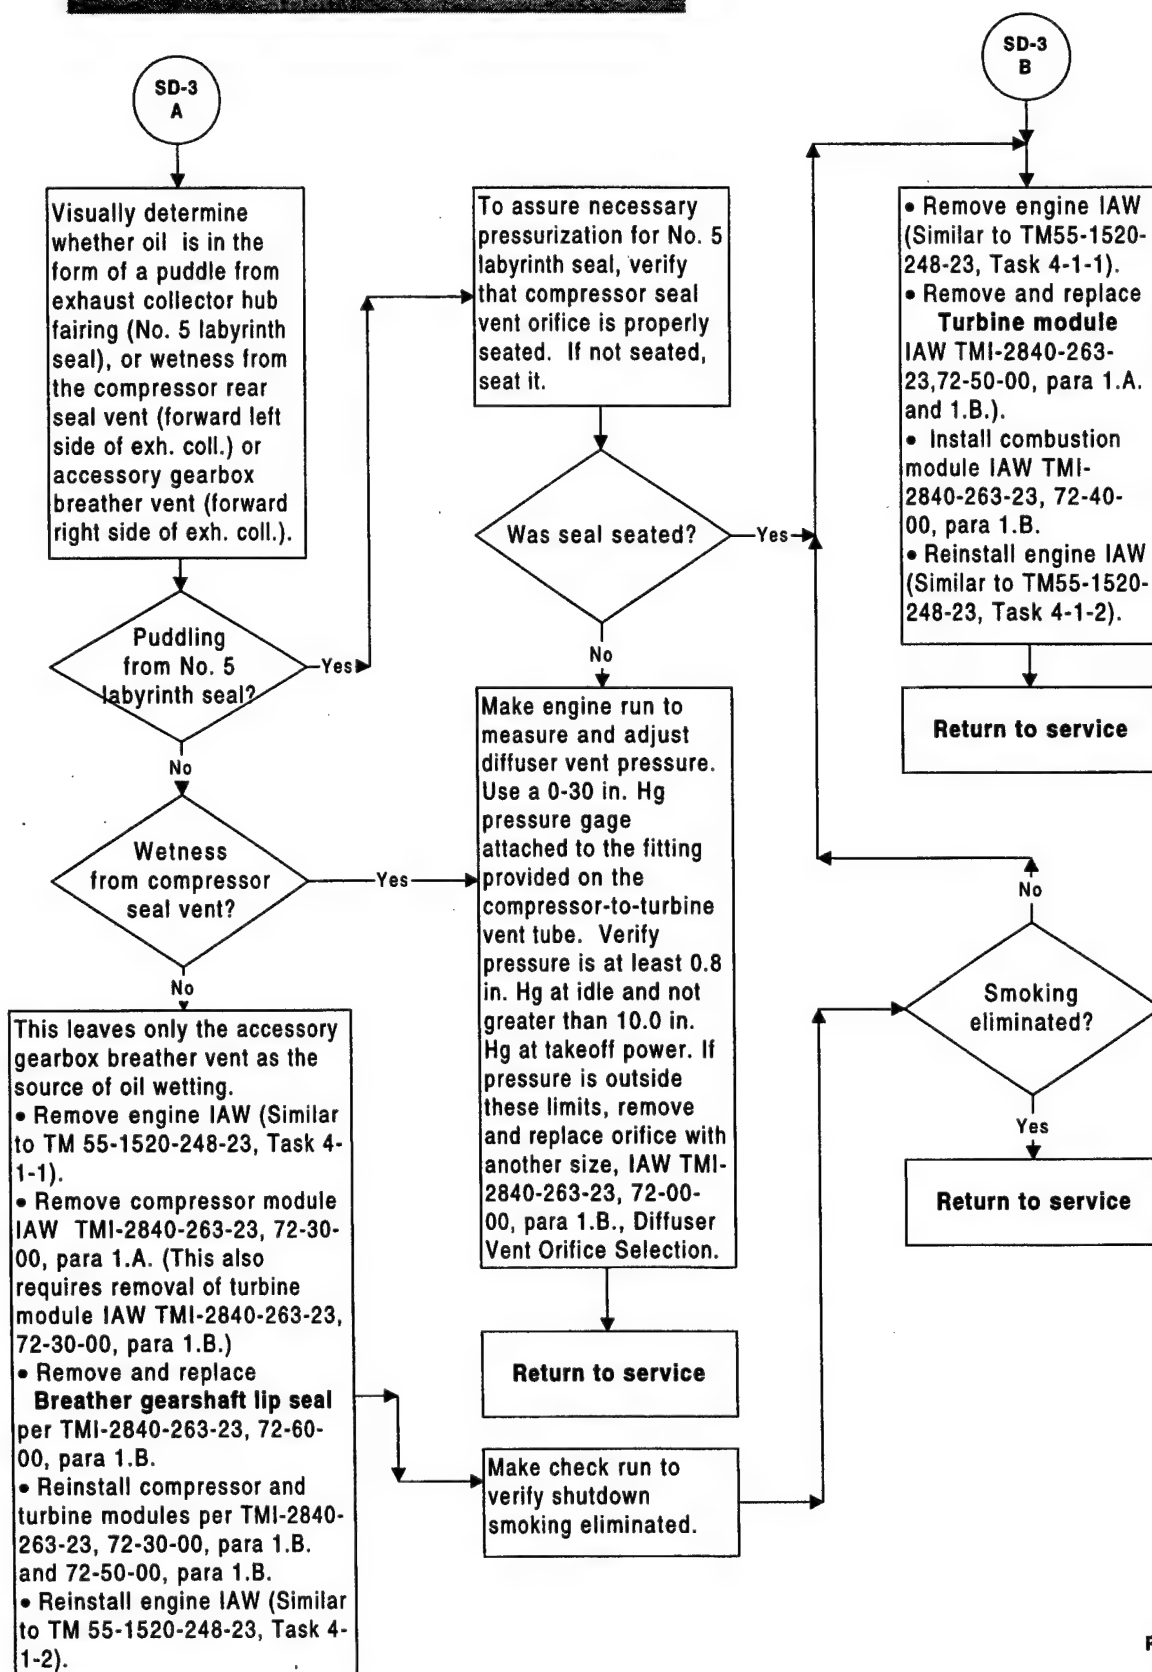
Page 2 of 6

# SD-3. Smoking During Shutdown

During coastdown, a brief puff of smoke is not abnormal, but a continuous plume is cause for corrective action. Among the causes of shutdown smoking are:

- Exhaust collector drain blocked
- Burner drain blocked
- Blocked power turbine scavenge strut
- Defective turbine seals
- Leaking No. 5 labyrinth seal
- Restricted scavenge flow from turbine
- Restricted scavenge flow in aircraft system
- Leaking oil transfer tubes or check valve
- Faulty oil pump
